## PHOTOGRAPHIC DOCUMENTATION

Appendix no. 2

to the Final report on the implementation of the measures specified in the EMP  
for Contract 3D.3

### Odra-Vistula Flood Management Project

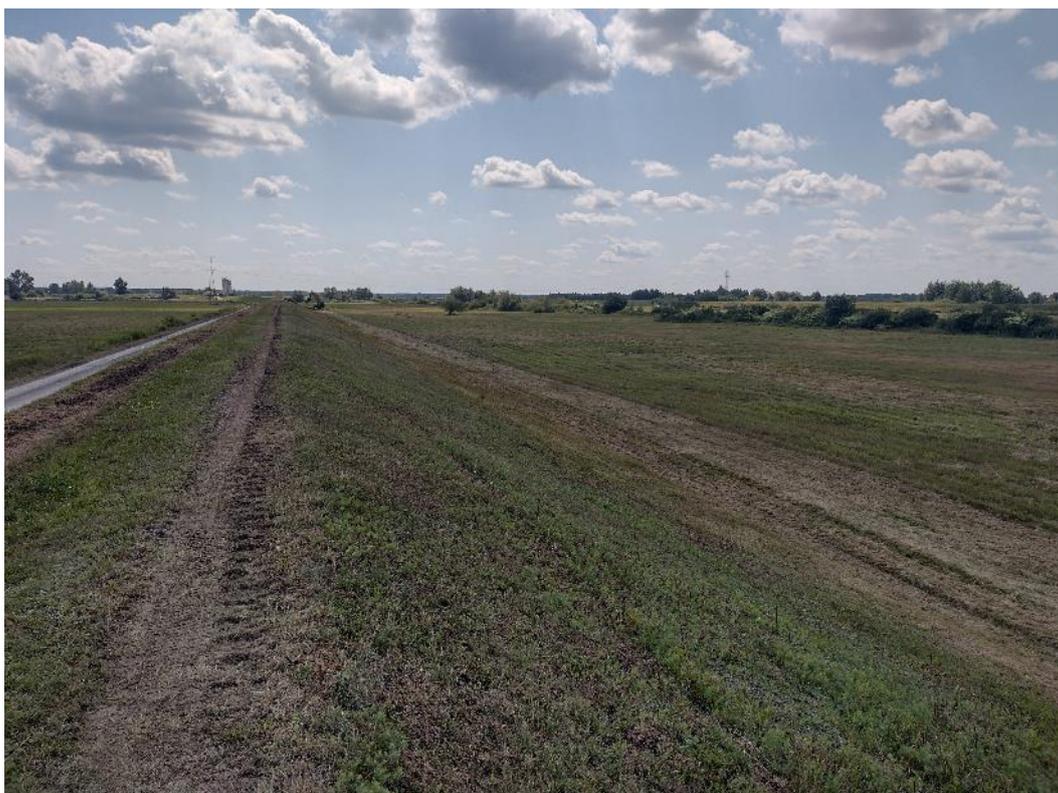
Phot. 1. View of the right embankment at km approx. 2+750 – status before the start of works, August 2021

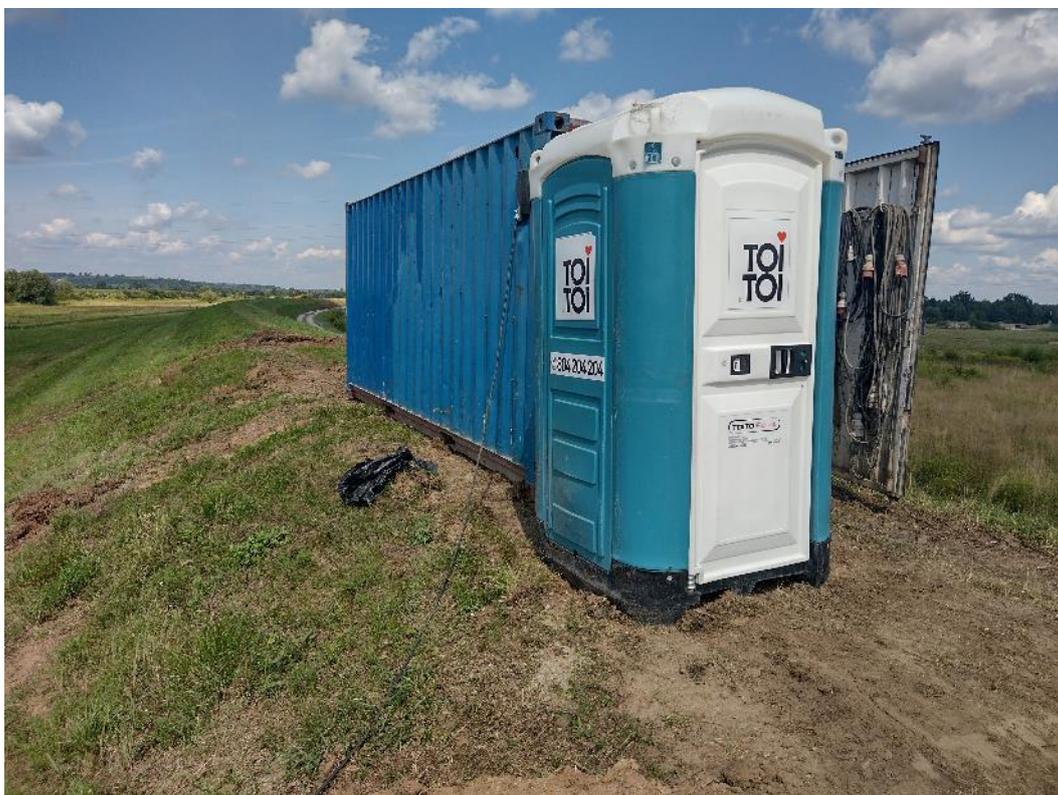
Phot. 2. View of the right embankment at km approx. 3+370 – organisation of the zone of site facilities including access to sanitary facilities, August 2021

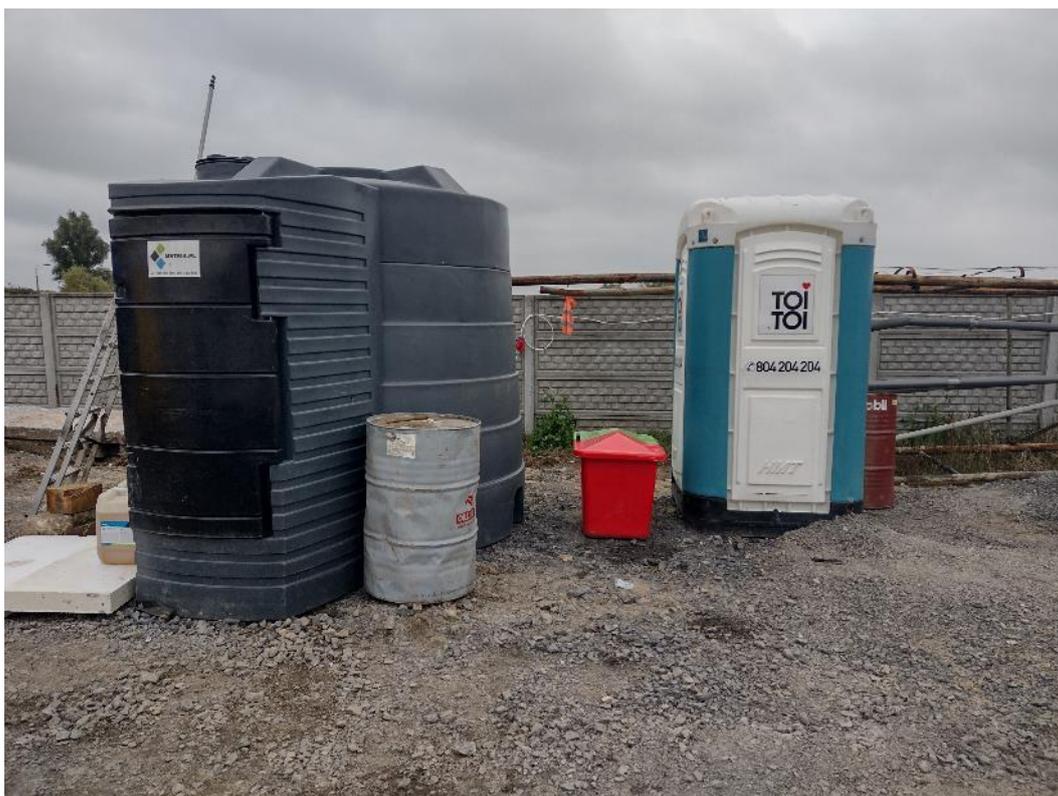
Phot. 3. Area of site facilities at the right embankment – equipment of the site facilities, in particular with access to sorbents and sanitary facilities, September 2021

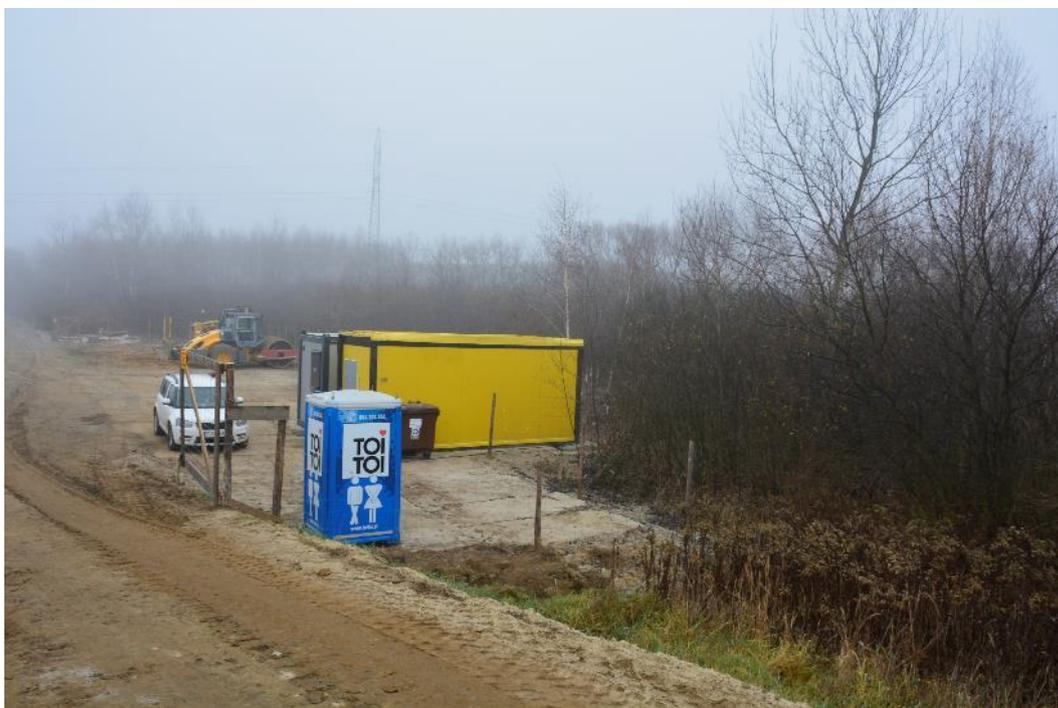
Phot. 4. View of the right embankment at km approx. 2+400 – proper preparation of the site facilities, November 2021

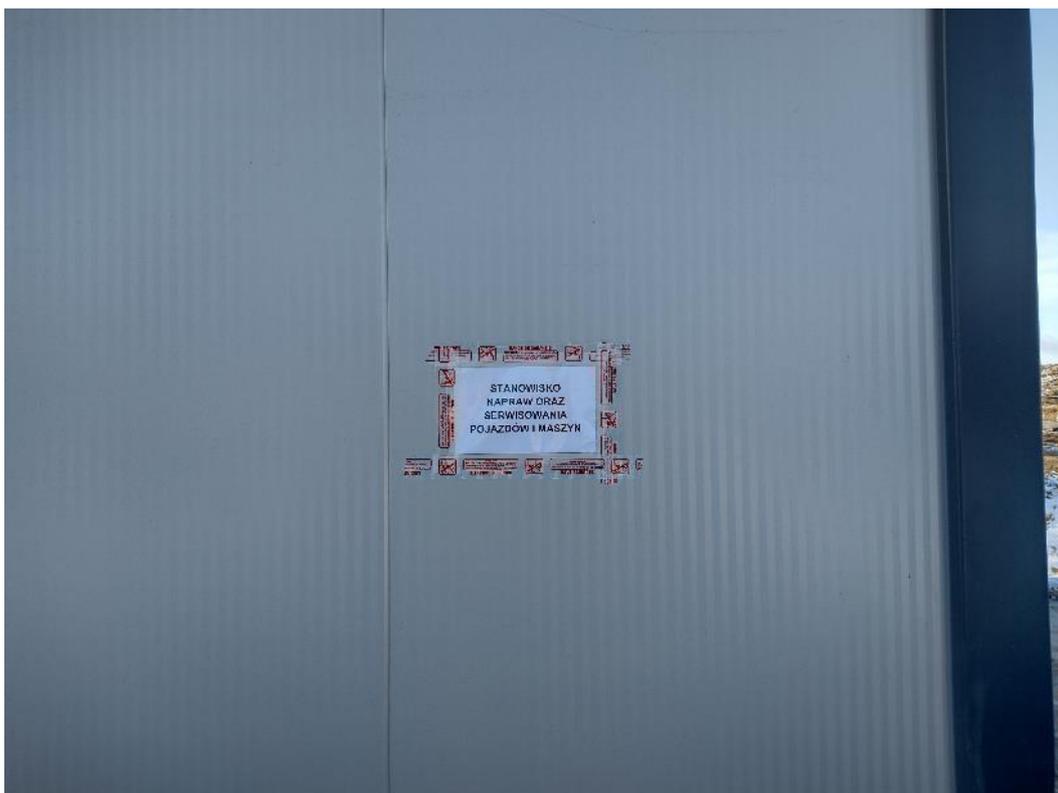
Phot. 5. View of the right embankment at km approx. 2+400 – site facilities – marking of the zone of repairs and servicing of vehicles and machines, January 2022

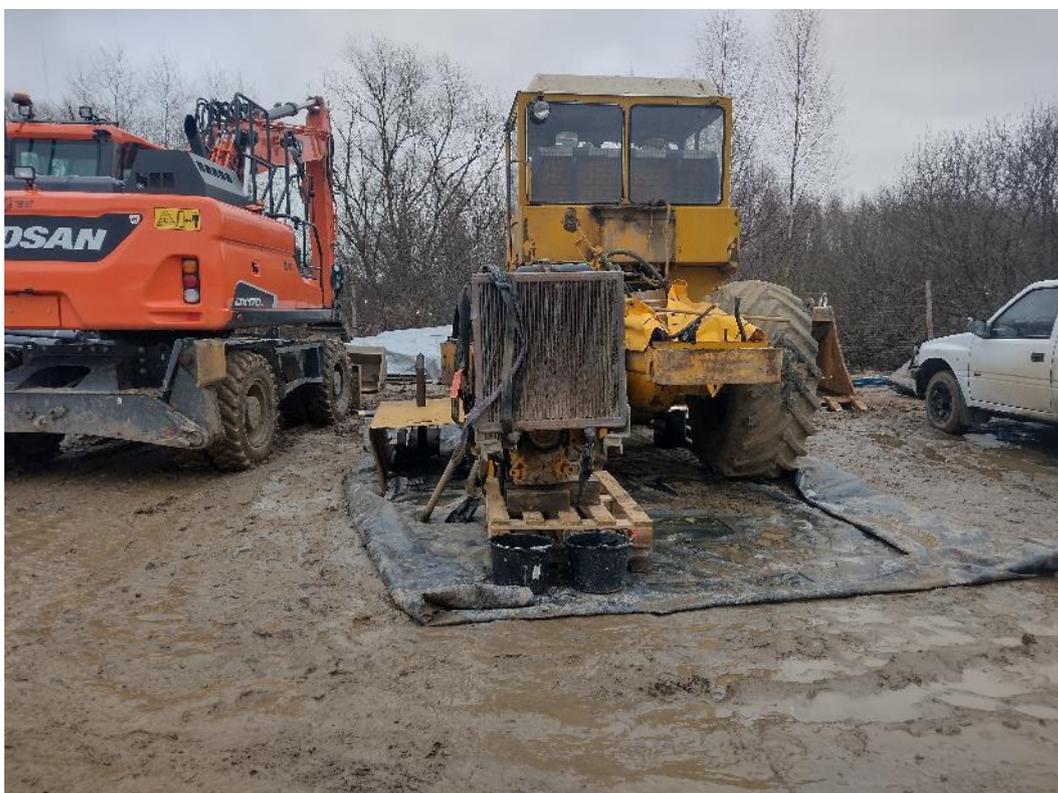
Phot. 6. View of the right embankment at km approx. 2+400 – site facilities – sealing of the subbase under serviced machines, January 2022

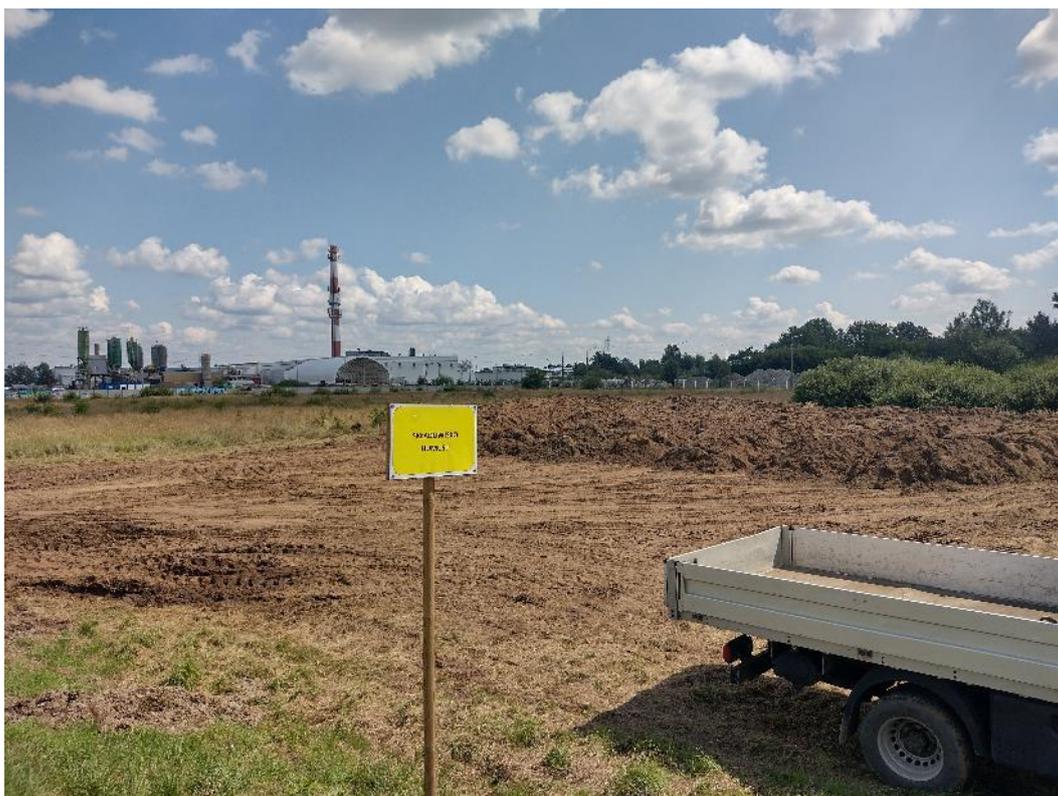
Phot. 7. View of the right embankment at km approx. 3+400 – prepared and marked topsoil storage area, August 2021

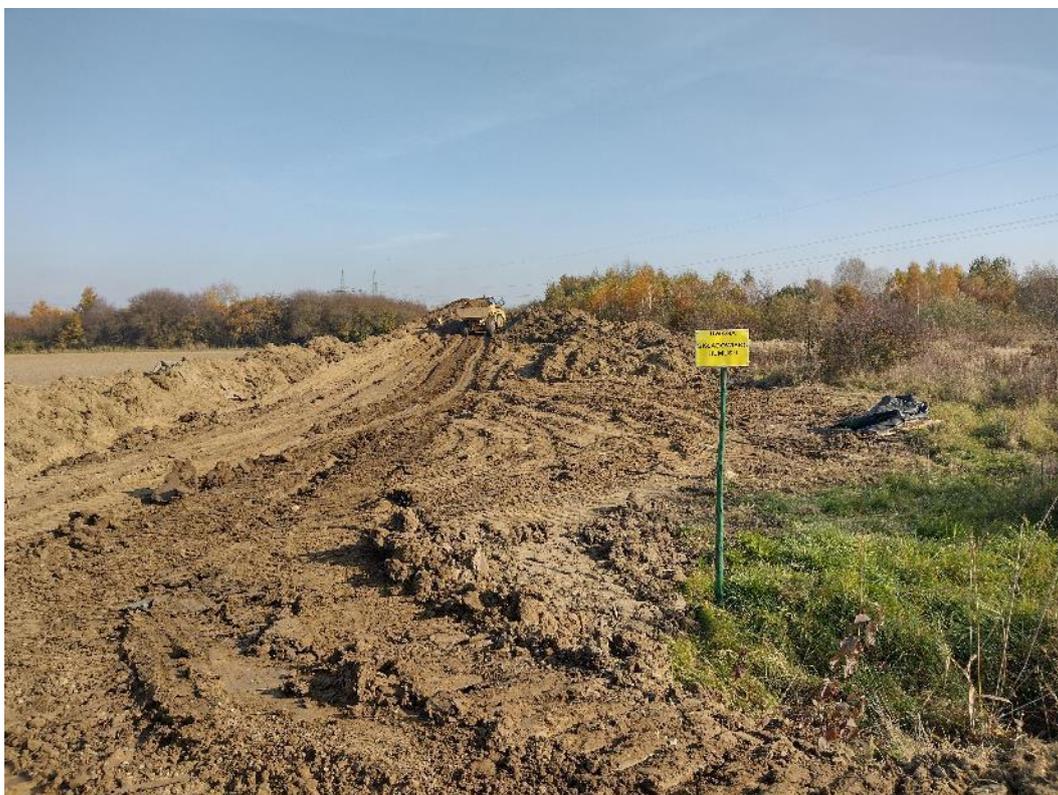
Phot. 8. View of the right embankment at km approx. 1+350 – marking of the topsoil storage area, October 2021

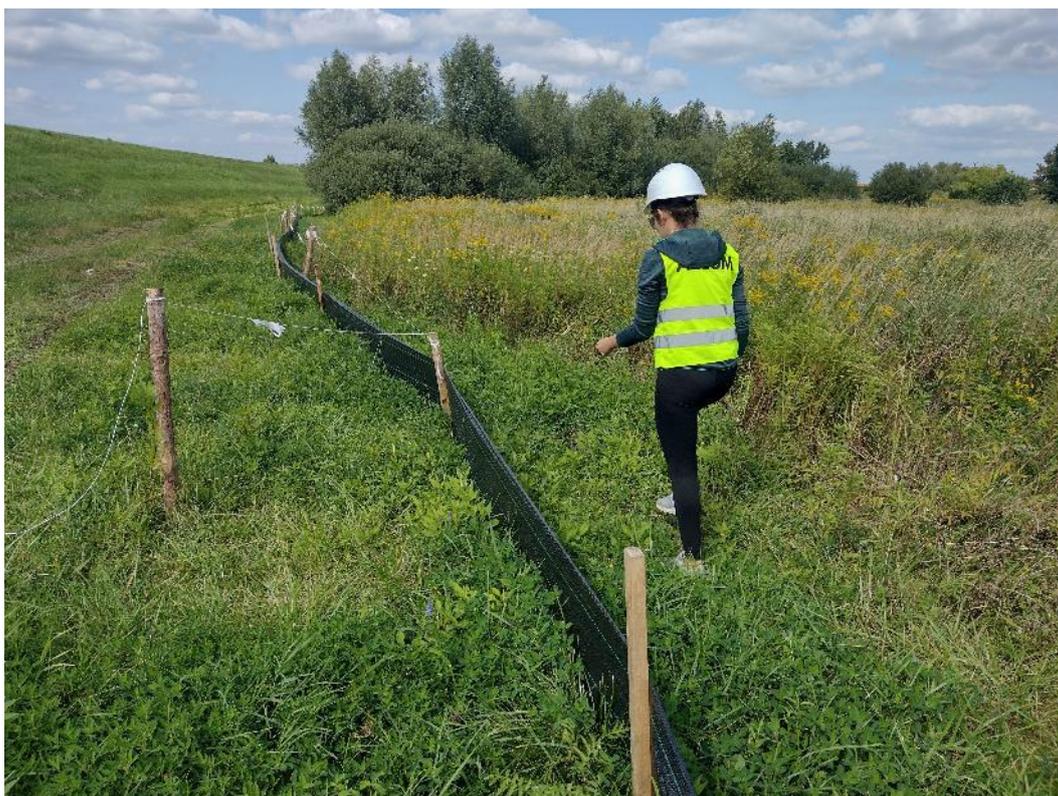
Phot. 9. View of the left embankment at km approx. 1+700 – inspection of the implementation status of herpetological fences, August 2021

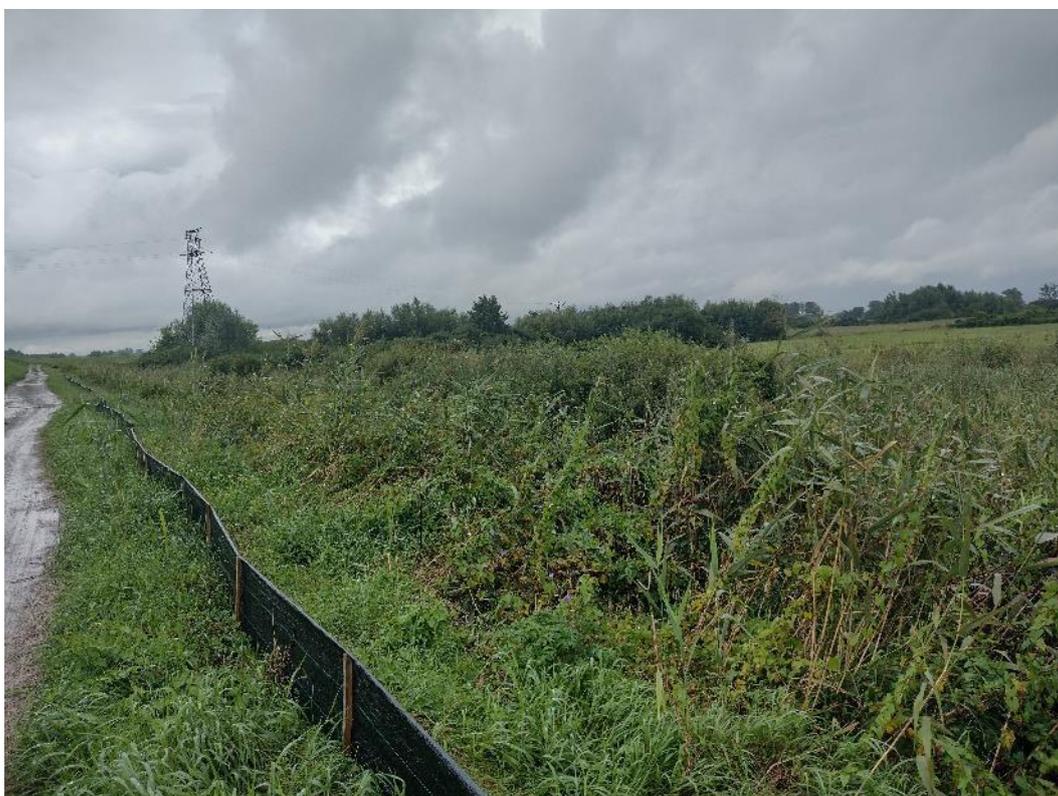
Phot. 10. View of the right embankment at km approx. 1+120 – correctly executed herpetological fences, August 2021

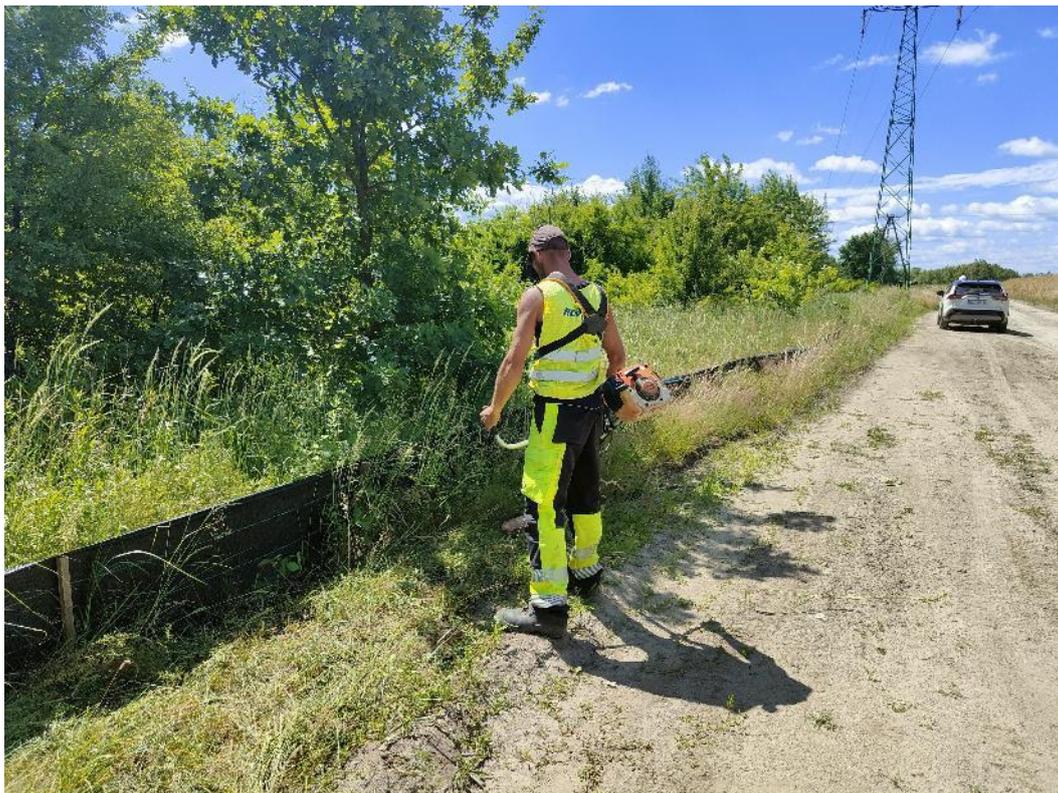
Phot. 11. View of the right embankment at km approx. 1+900 – mowing of vegetation along the herpetological fences, June 2022

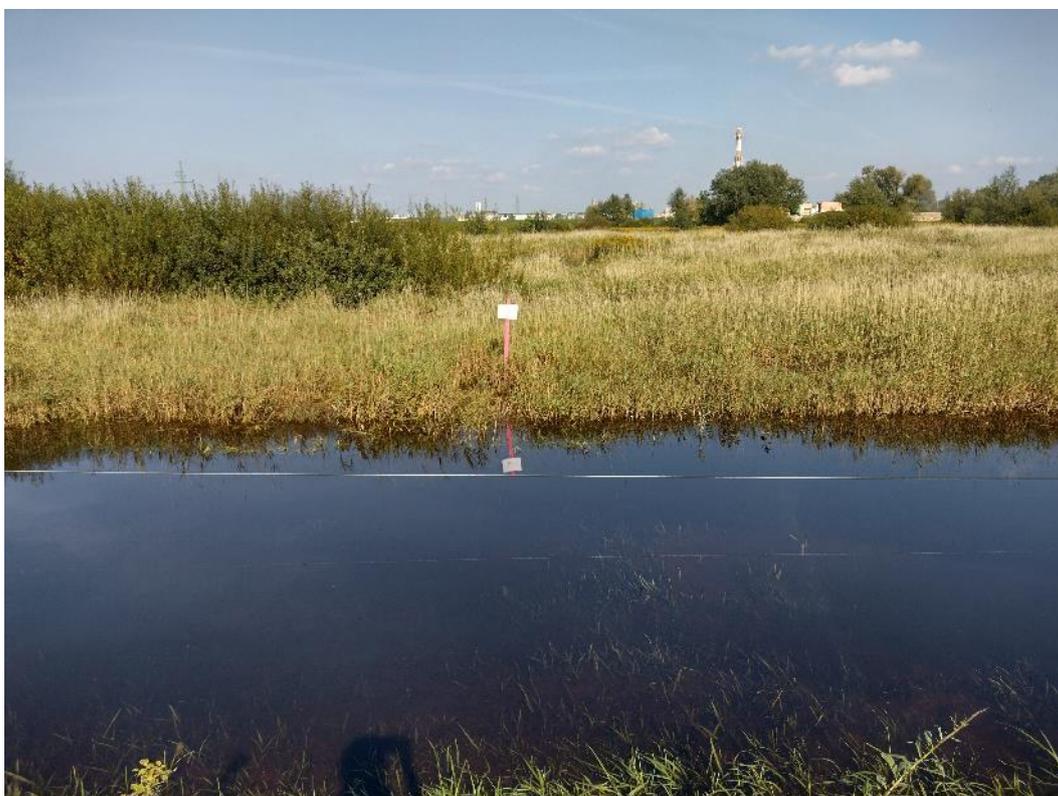
Phot. 12. View of the left embankment at km approx. 3+000 – marking of valuable habitats of flora and fauna, September 2021

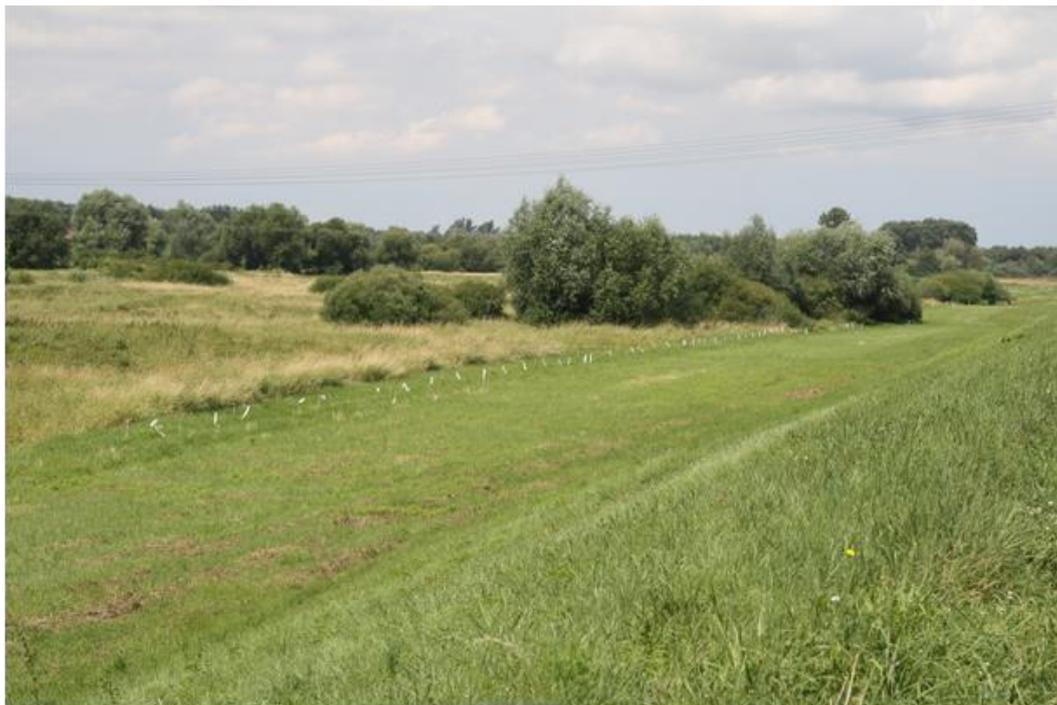
Phot. 13. View of the right embankment at km approx. 3+300 – marking of delimitation lines of the site, September 2021

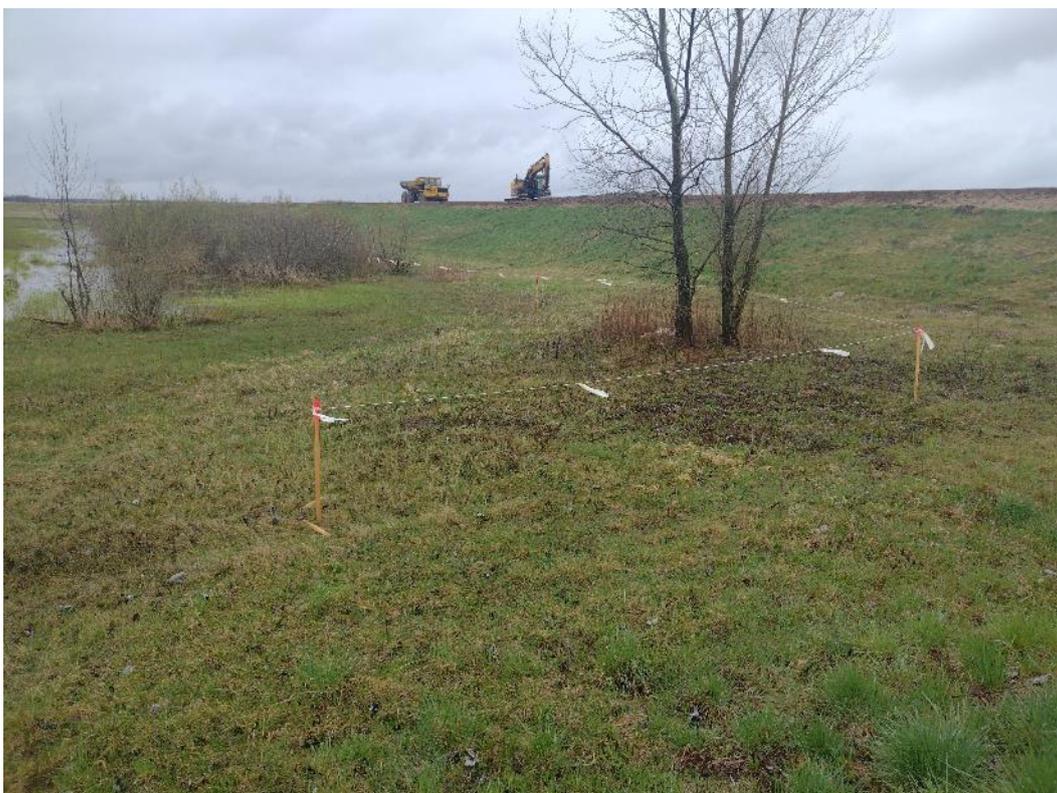
Phot. 14. View of the left embankment at km approx. 3+050 – marking of boundaries of works area, April 2022

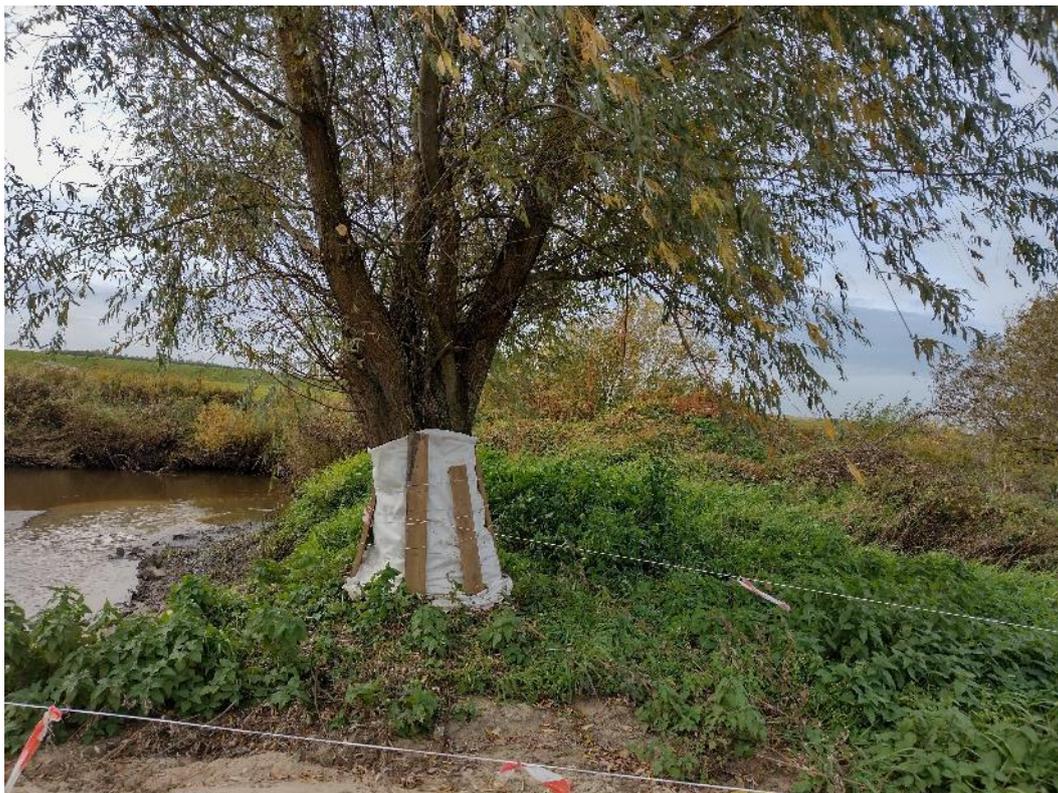
Phot. 15. View of the right embankment at km approx. 3+850 – fencing of trees left outside felling and marking of boundaries of the works area, October 2021

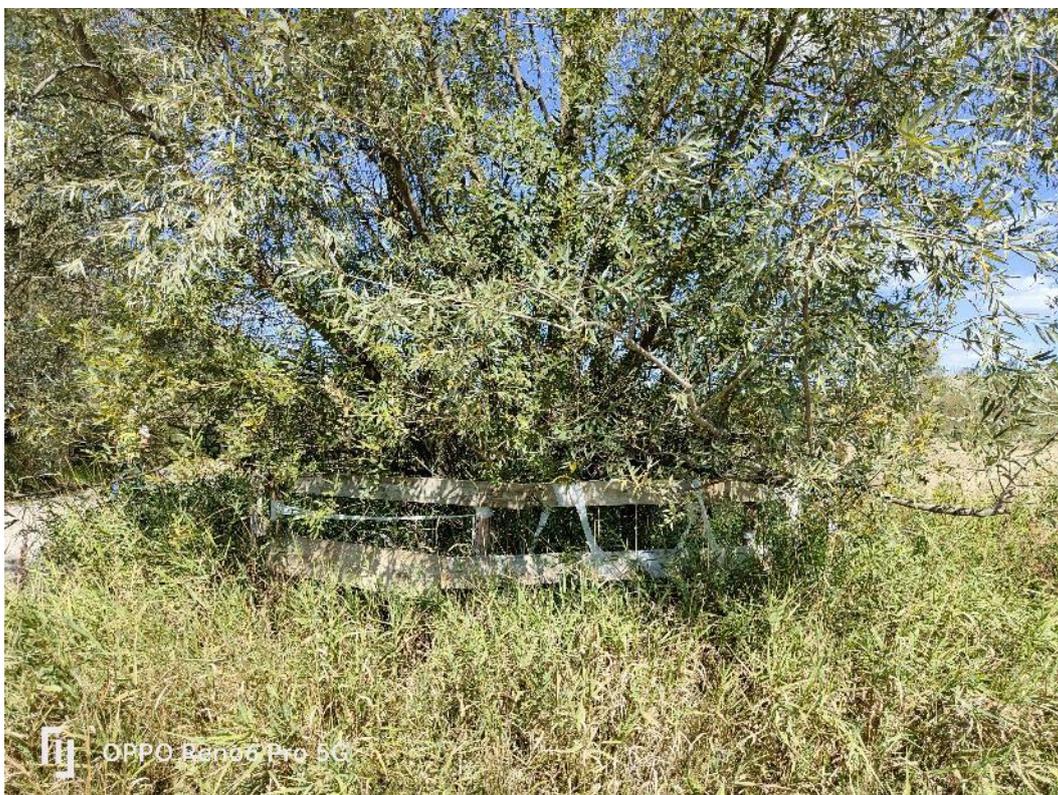
Phot. 16. View of the right embankment at km approx. 1+500 – fencing of trees left outside felling, June 2022

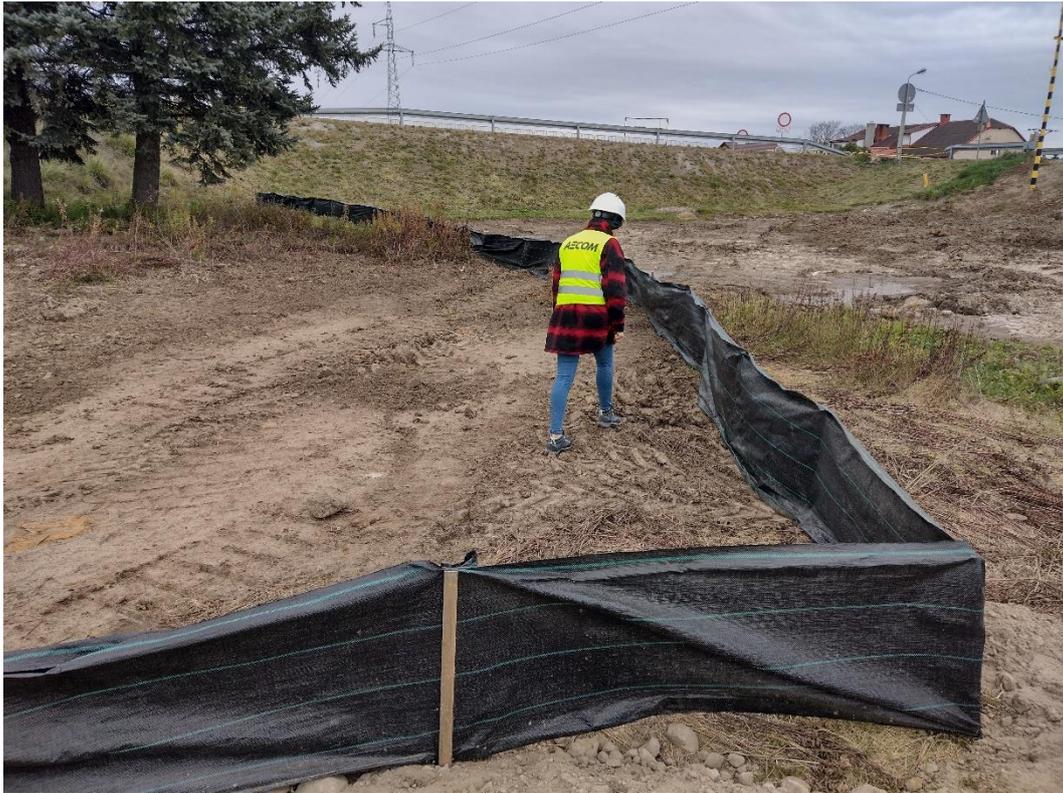
Phot. 17. View of the right embankment at km approx. 1+800 – nature monitoring - inspection of fences for herpetofauna for the activity of amphibians in the period of autumn migrations, October 2021

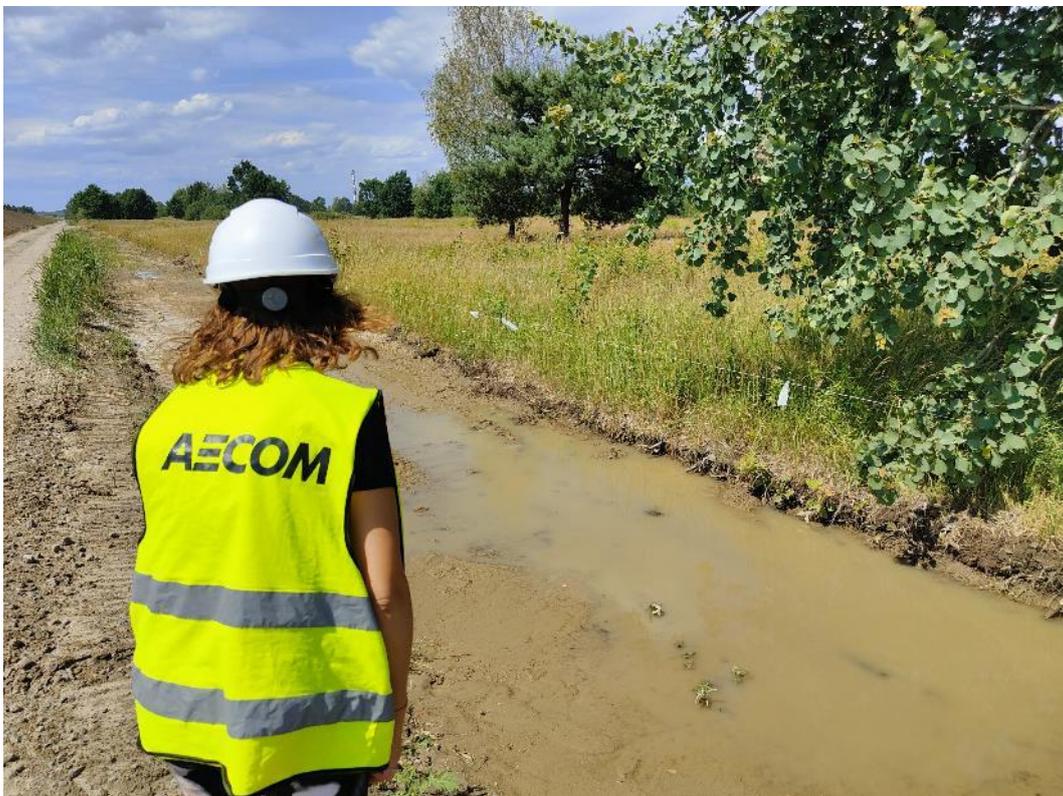
Phot. 18. View of the right embankment at km approx. 4+500 – nature monitoring - inspection of stagnant water formed after precipitations for the presence of amphibians, July 2022

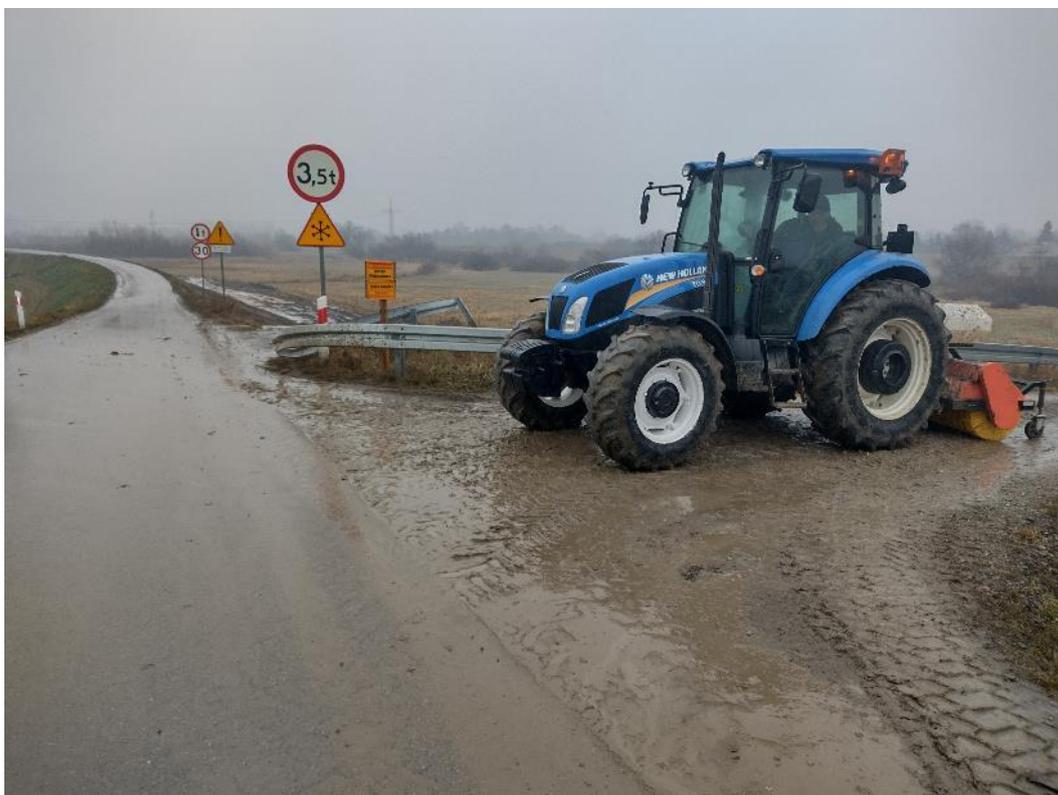
Phot. 22. View of the left embankment at km approx. 1+100 – keeping the access roads to the construction site clean, December 2021

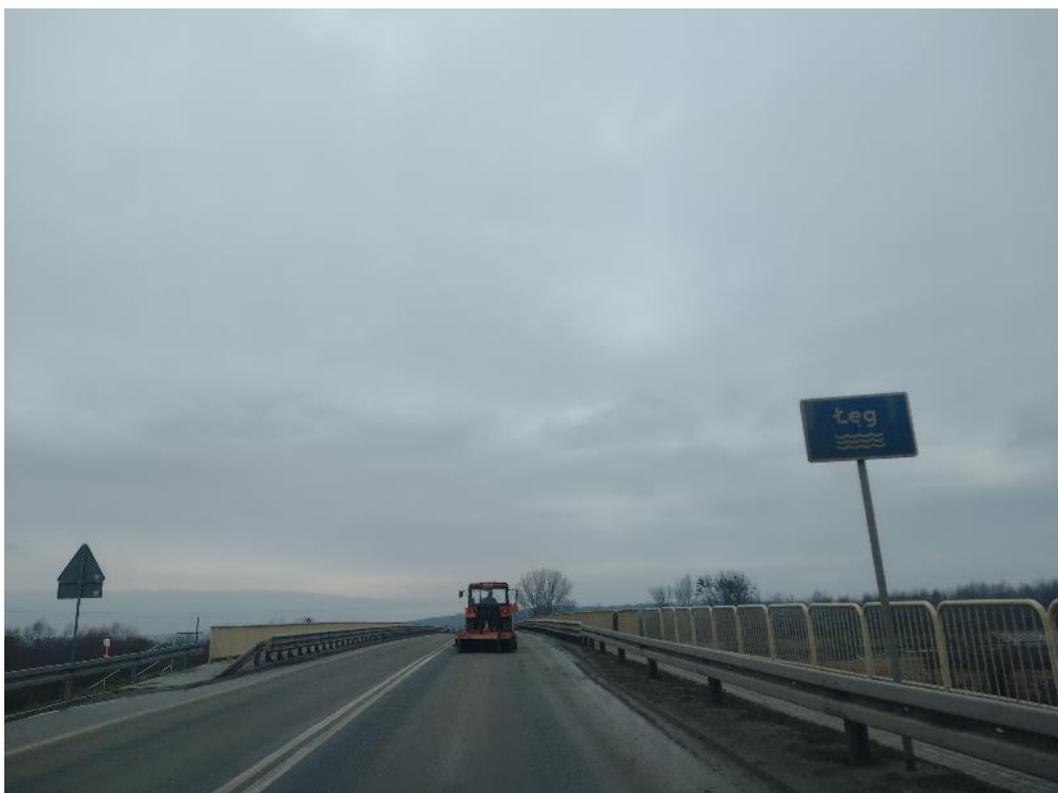
Phot. 23. View of the national road no. 77 – clearing the road at the section of the exit and entrance to the site, January 2022

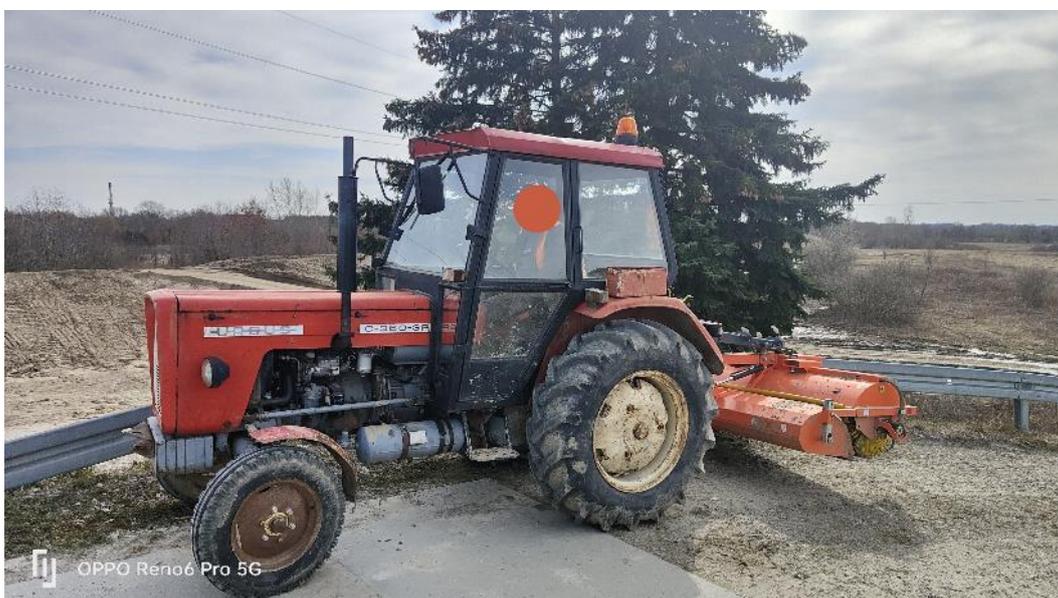
Phot. 24. View of the area around the intersection of the right embankment with national road no. 77 – keeping the access roads to the site clean, March 2023

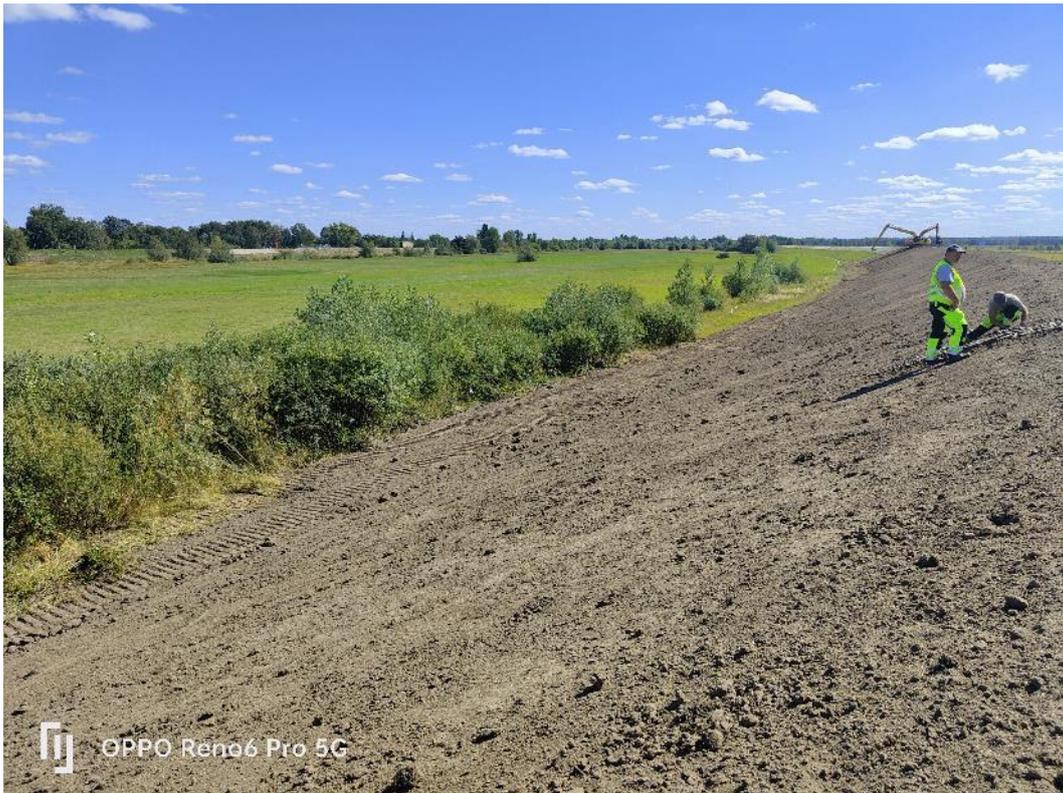
Phot. 25. View of the left embankment at km approx. 2+400 – spreading the topsoil after executing the embankment extension works, September 2022

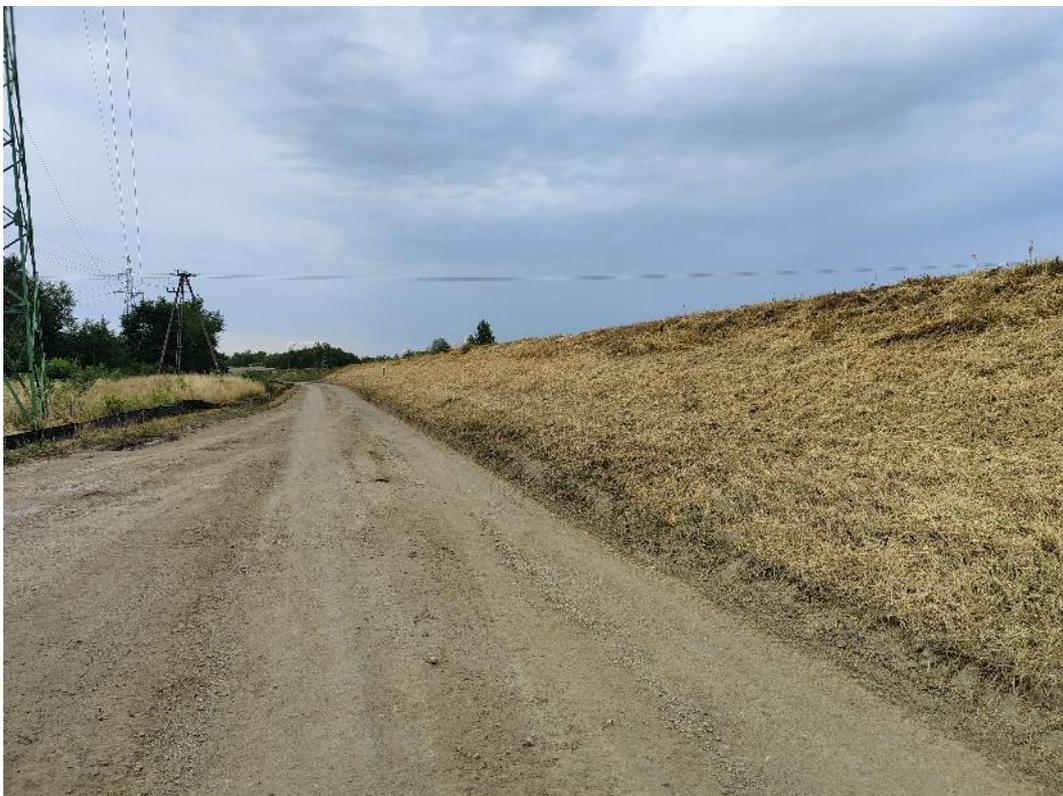
Phot. 26. View of the right embankment at km approx. 2+000 – mowing of grass near the embankments, July 2022

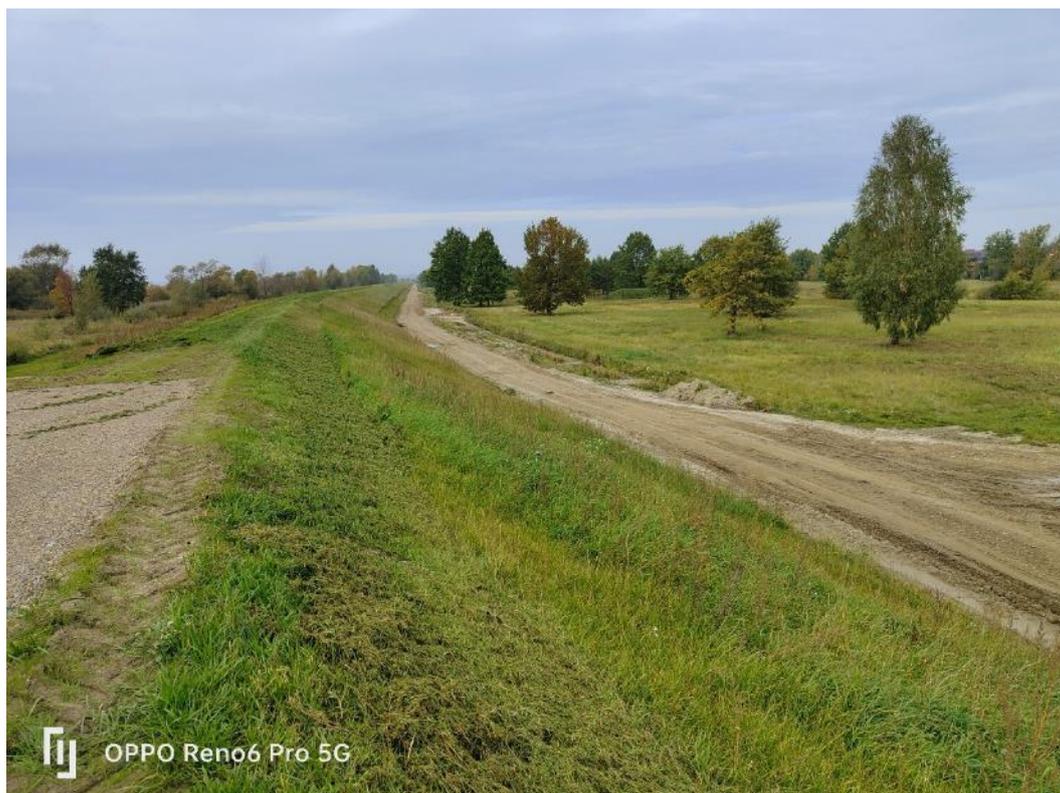
Phot. 27. View of the left embankment at km approx. 5+100 – a visible measure started aimed at performing pre-winter mowing, October 2022

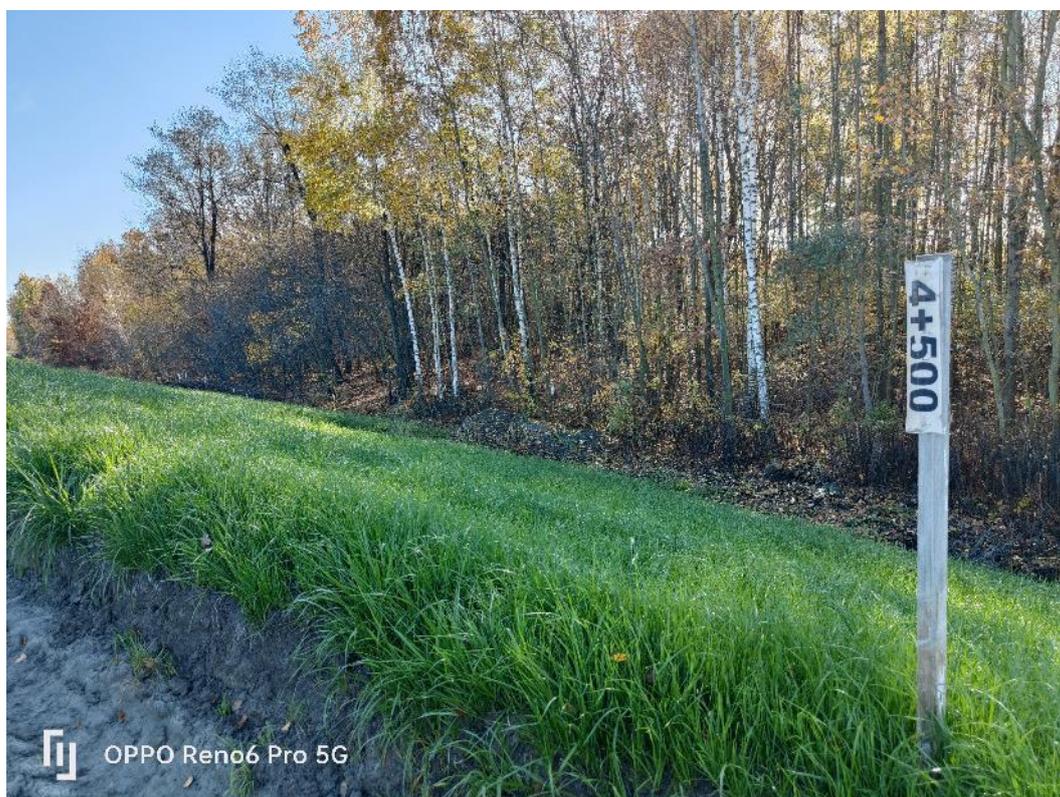
Phot. 28. View of the left embankment at km approx. 4+500 – grass growth after sowing, November 2022

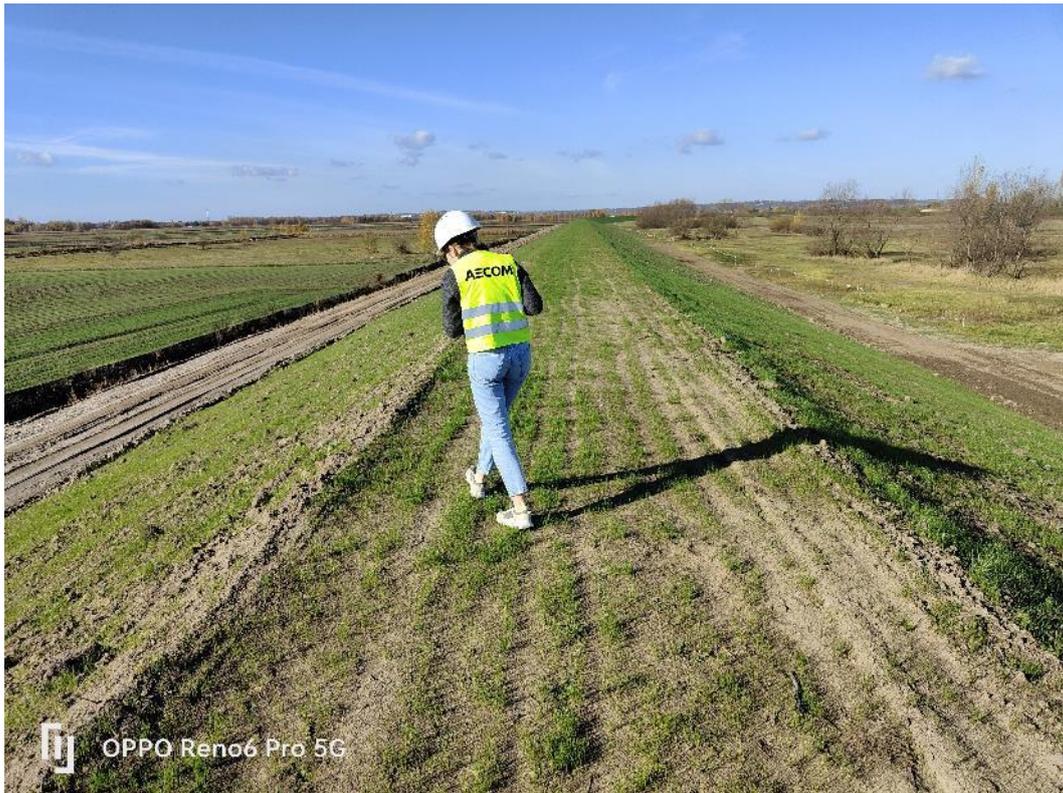
Phot. 29. View of the left embankment at km approx. 3+900 – inspection of grass sowing along the section of completed embankment extension and rehabilitation works, November 2022
