## PHOTOGRAPHIC DOCUMENTATION

Appendix no. 2

to the Final report on the implementation of the measures specified in the EMP  
for Contract 3D.3

### Odra-Vistula Flood Management Project

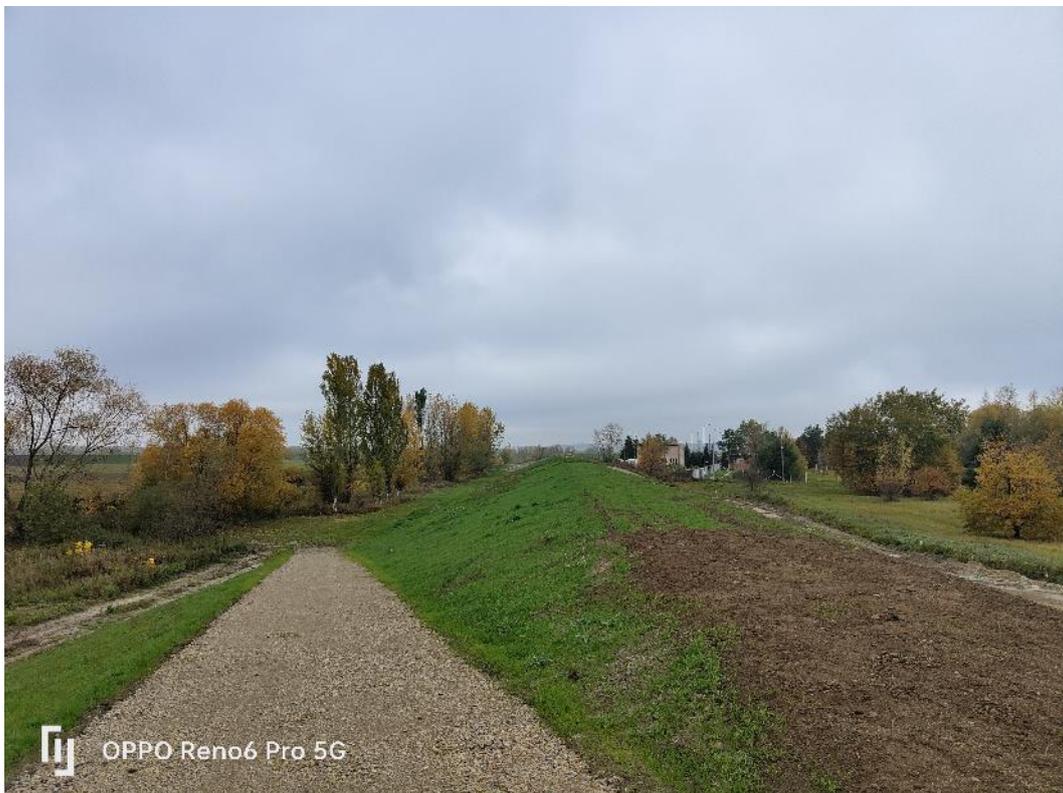
Phot. 30. View of the right embankment at km approx. 3+900 – view of the completed embankment extension and rehabilitation works, October 2022

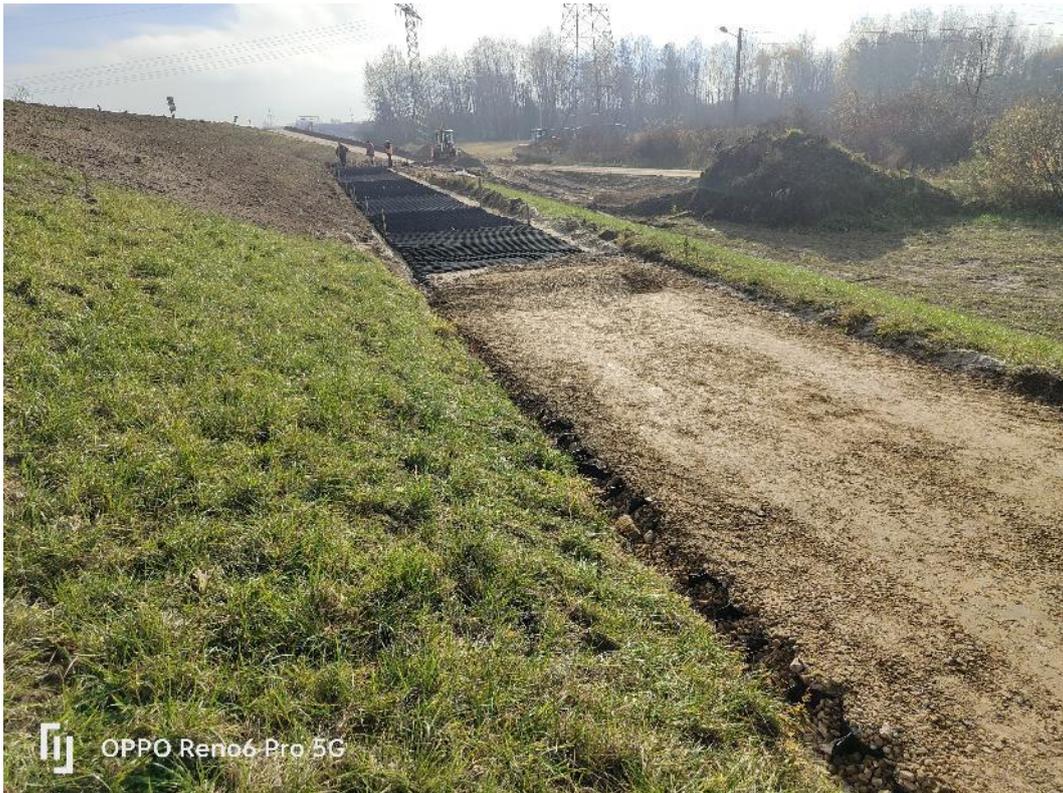
Phot. 31. View of the left embankment at km approx. 1+100 – view of hardening works for service roads, November 2022

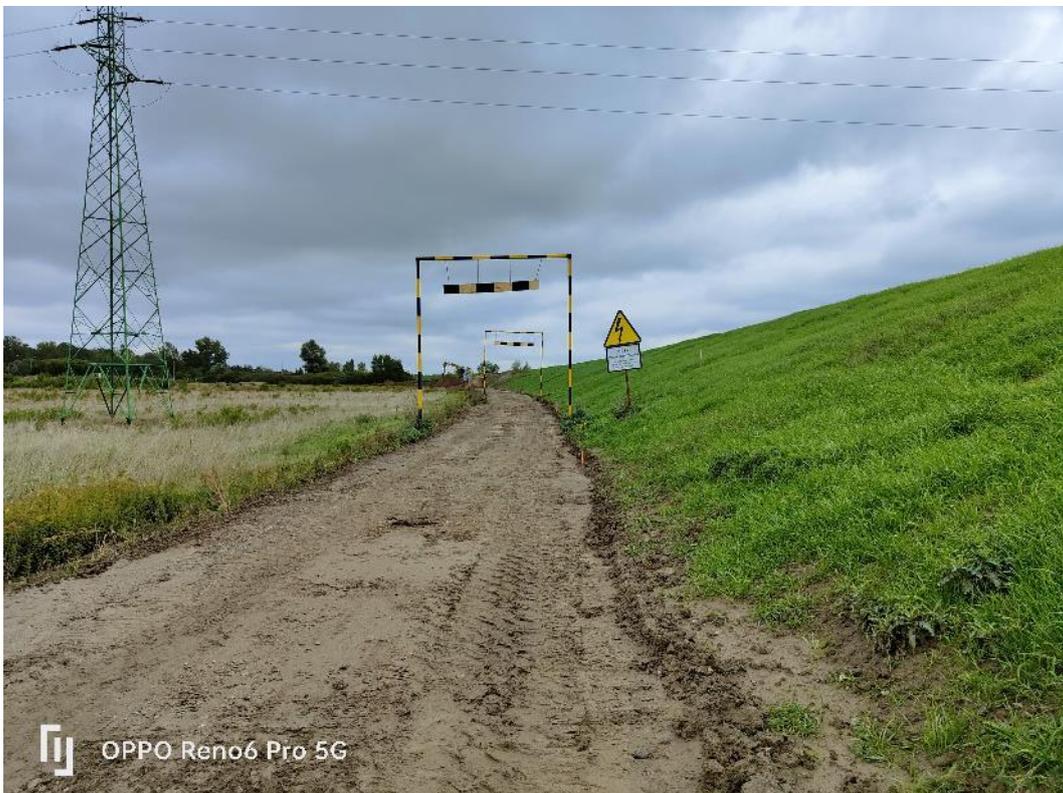
Phot. 32. View of the right embankment at km approx. 4+100 – gate structures - protection zones under the active power line, September 2022

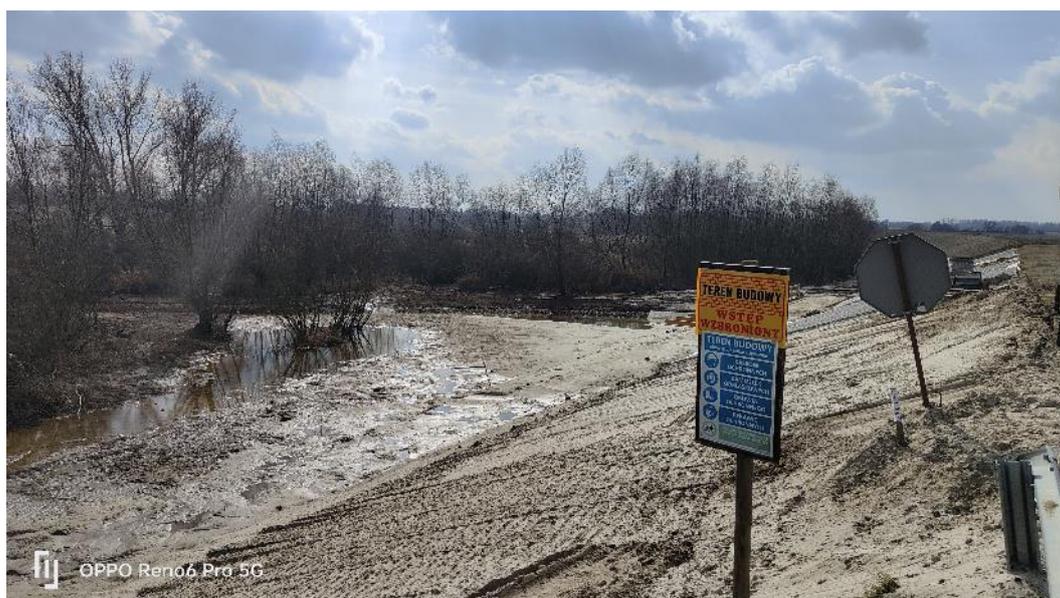
Phot. 33. View of the left embankment at km approx. 1+200 – correct marking of the construction site, March 2023

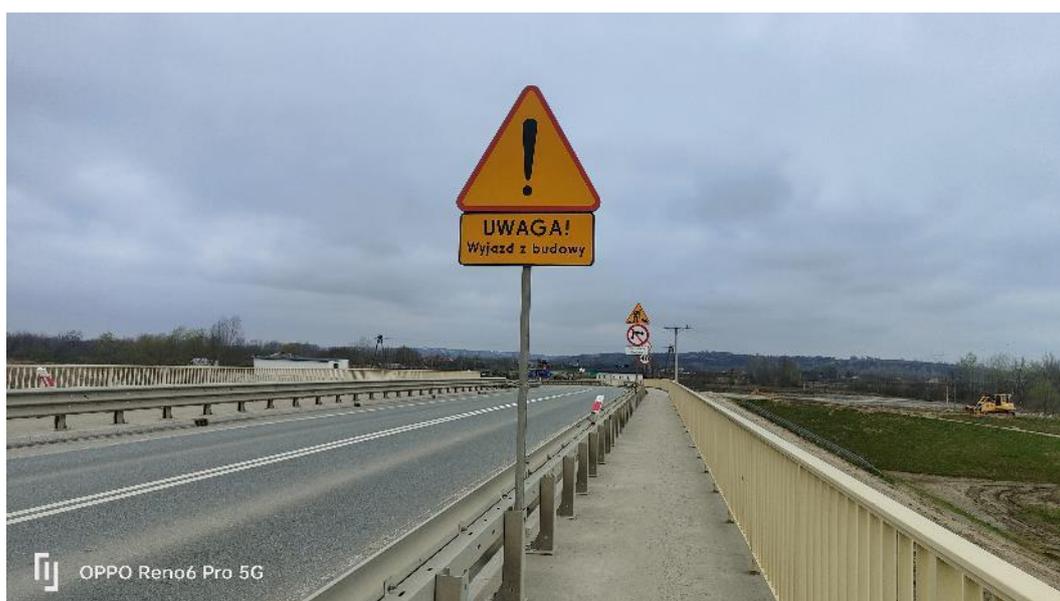
Phot. 34. View of the area around the intersection of the left embankment with national road no. 77 – marking of the exit from the construction site, March 2023

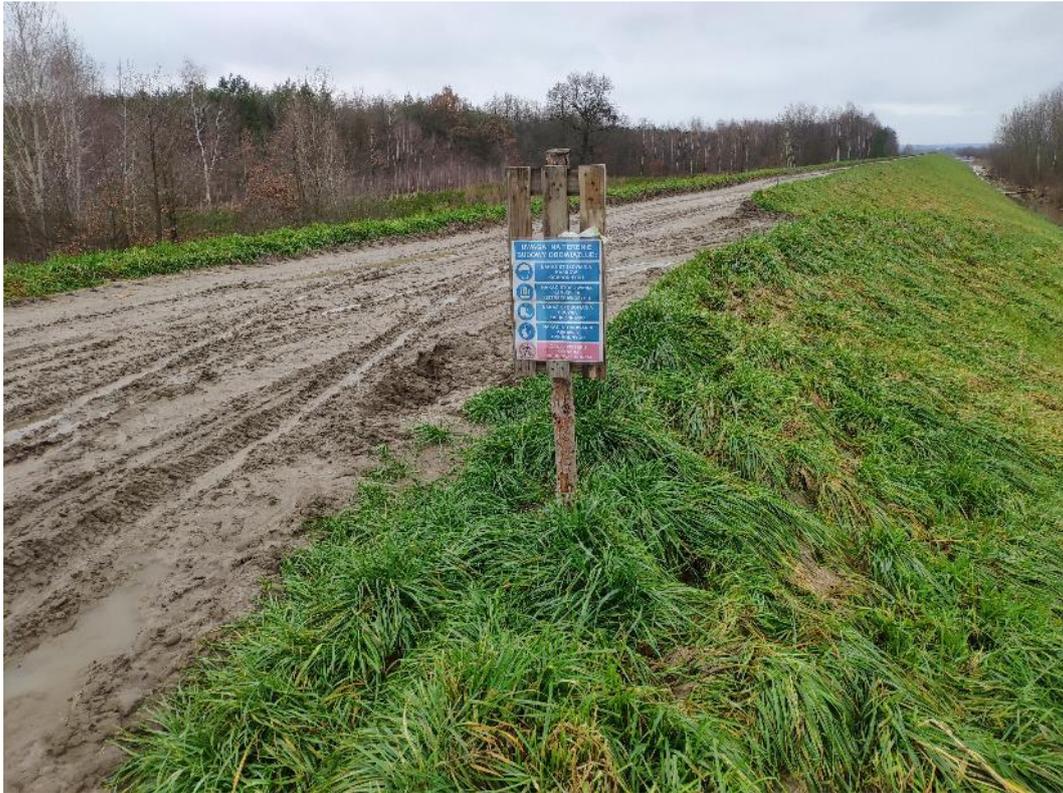
Phot. 35. View of the left embankment at km approx. 5+000 – marking of the construction site area, January 2023

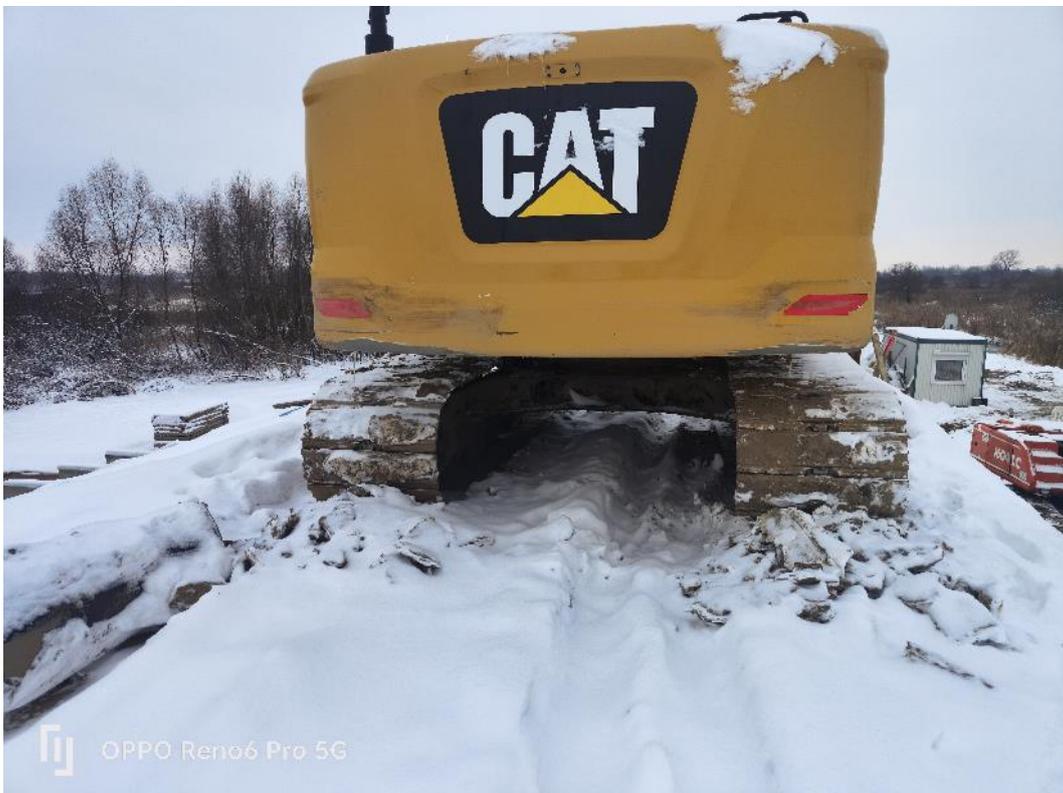
Phot. 36. View of the left embankment at km approx. 1+200 – inspection of construction vehicles - no spills of petroleum derivatives, December 2022

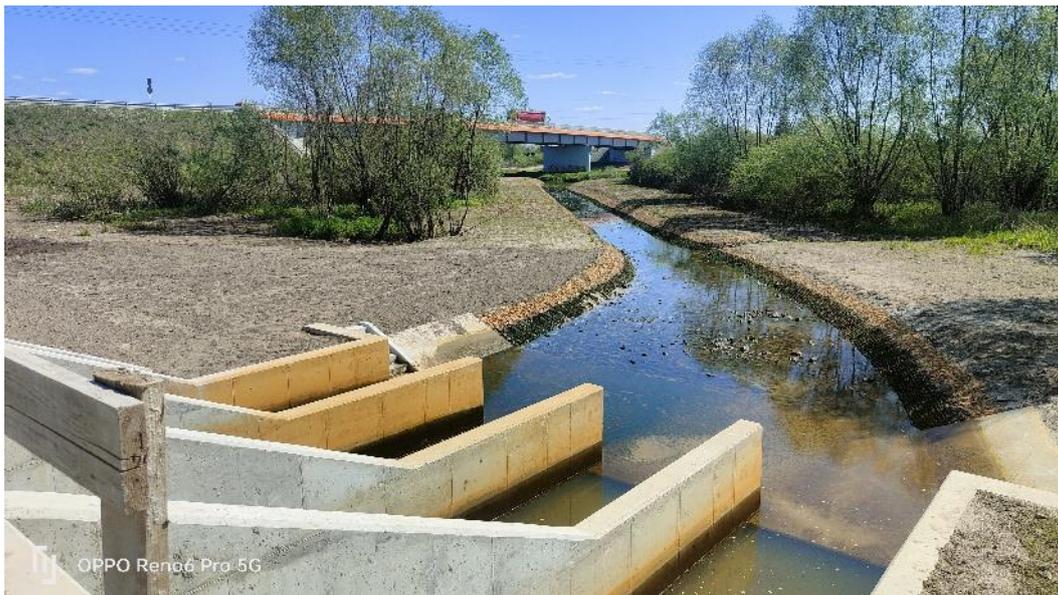
Phot. 37. View of the pumping station in the left embankment area – view of the completed works, May 2023

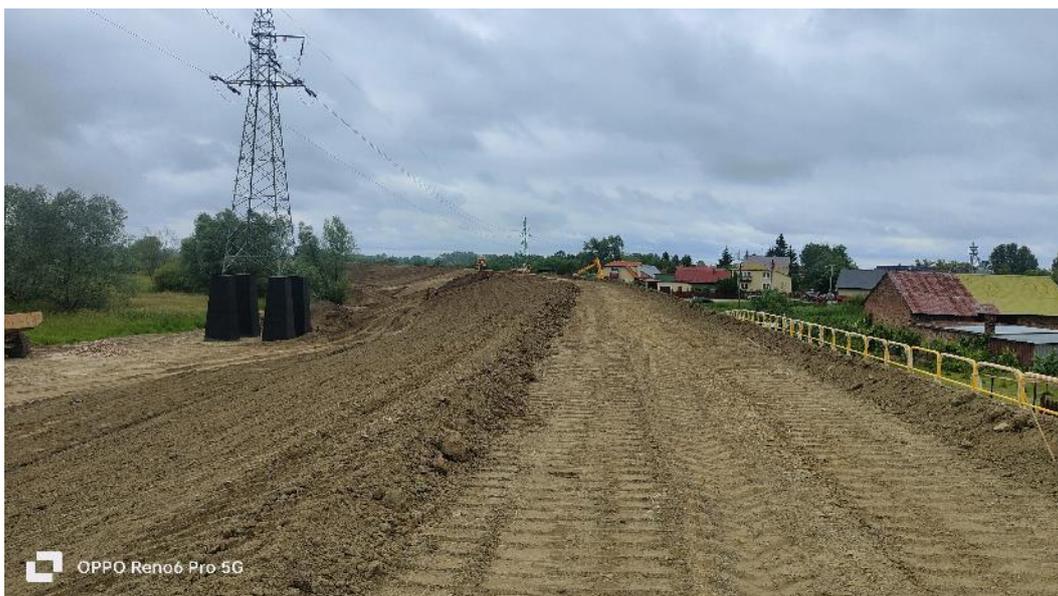
Phot. 39. View of the right embankment at km approx. 1+700 – land reclamation works completed, preparation of the section for sowing with mixtures of grasses, June 2023

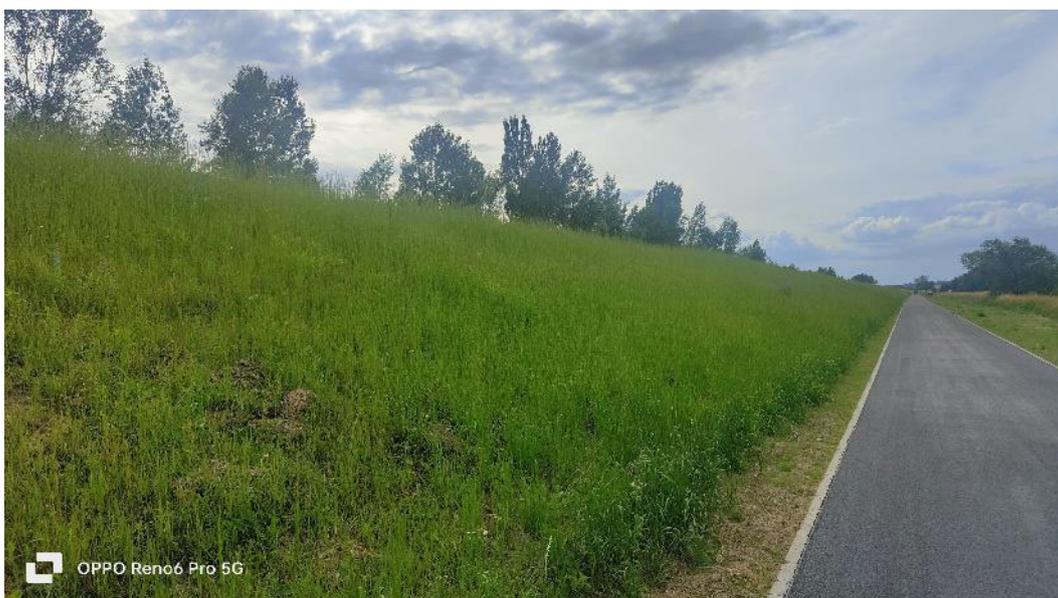
Phot. 40. View of the right embankment at km approx. 4+800 – completed construction of embankment roads, view of grass growth after sowing, June 2023

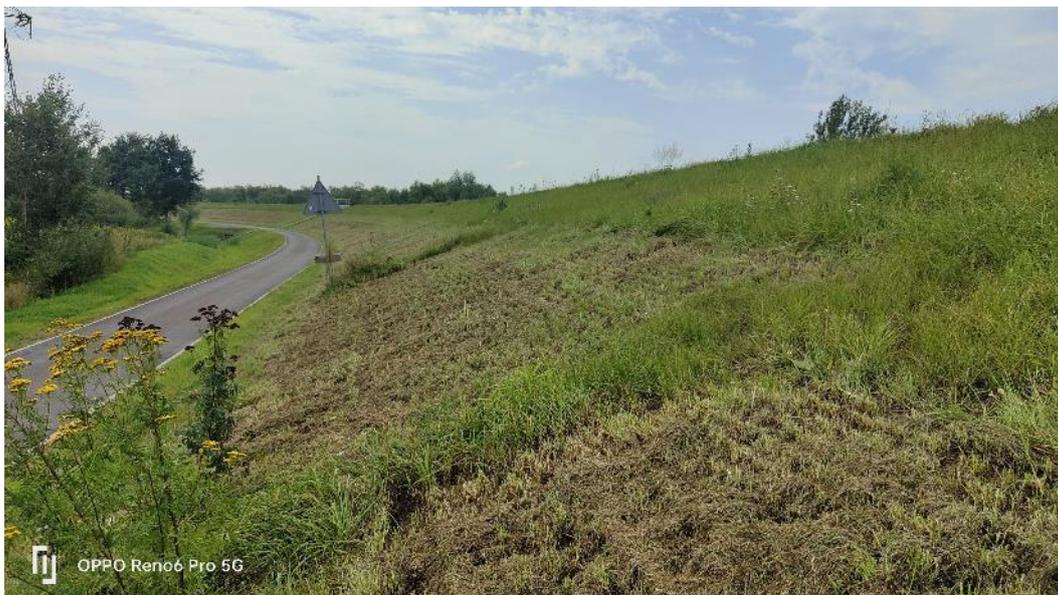
Phot. 44. View of completed works in the area of the right embankment, including the completed maintenance works for grassed areas on the embankment, August 2023

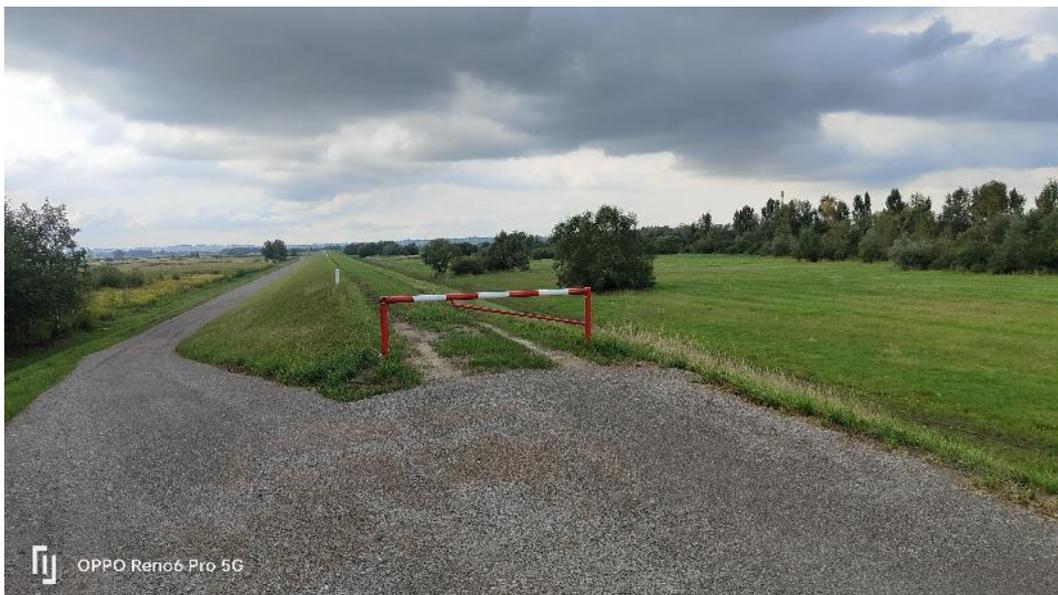
Phot. 46. View of completed works in the area of the left embankment, including the completed barriers, August 2023

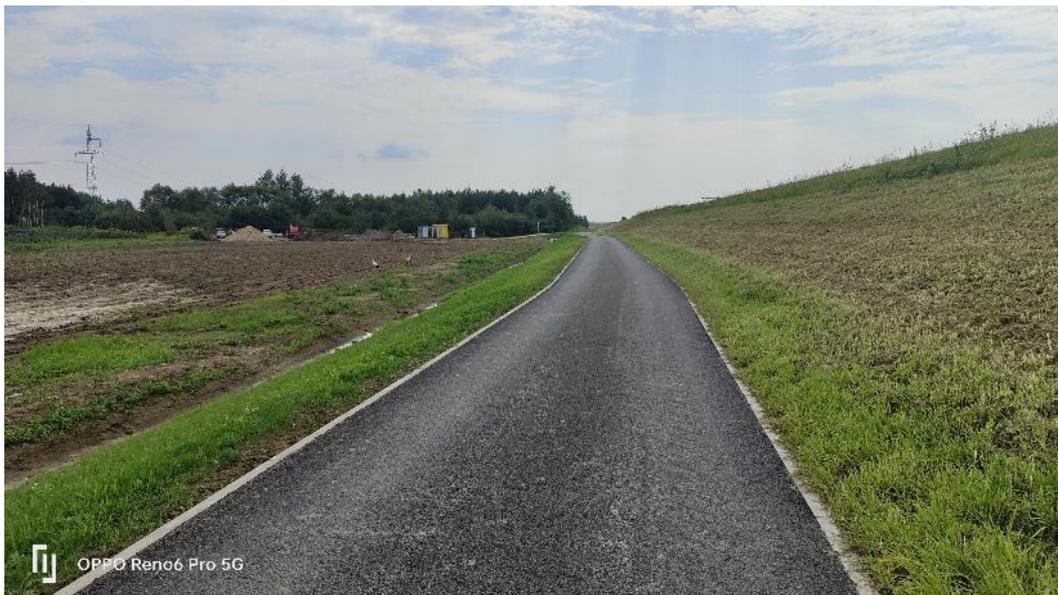
Phot. 47. View of completed works in the area of the right embankment, including the completed grass mowing, August 2023
